Firmware Version: F111-S306NCM-C02_R09

Filename: NB12WD-F111-S306NCM-C02_R09.bin

> Date: 05, October, 2009

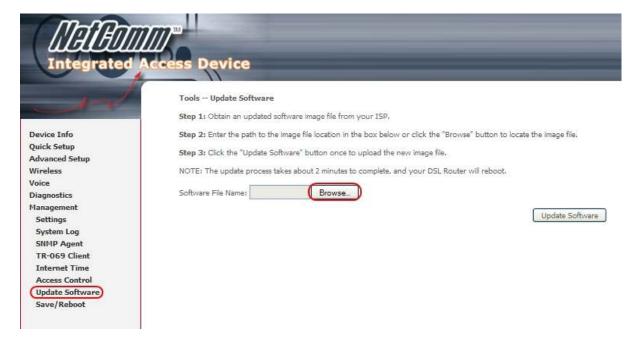
- 1. Connect the computer to any LAN socket on the NB12WD.
- 2. Open the web browser (IE, Mozila firefox, etc) on the computer, type in http://192.168.1.1 on the address bar, and then press **Enter**.
- 3. On the left-hand side menu, click on Management > Update Software;

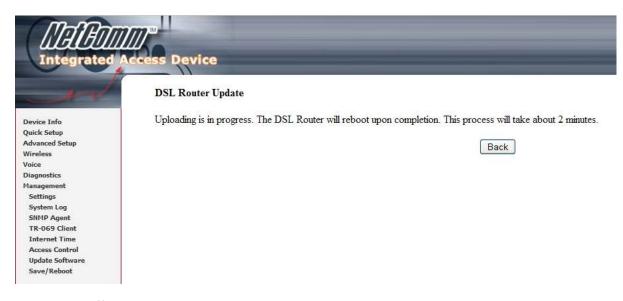
- 4. On the right-hand side, click on the **Browse** button to search your local hard drive and locate the firmware to be used for update. Select the firmware file and press **Open.**
- 5. Click **Update Software** to proceed. It will take a few minutes until a message show up to indicate the upgrade succeeds.

- 6. Do not turn off the modem during the upgrade.
- 7. Please double check if the software version is F111-S306NCM-C02_R08 as shown in above screenshot, go to next step if it is, otherwise, please go back to step 1.
- 8. Go to Management > Restore Default, click "Restore Default Settings" button then click ok in the pop up window to implement restore default settings on NB12WD.
